# BRANZ Type Test

## ST1073-TT [2015]

### STRENGTH OF NON-STRUCTURAL COMPONENT SUPPORT BRACKETS FITTED TO THE UNDERSIDE OF 200MM HOLLOW CORE SLAB UNITS

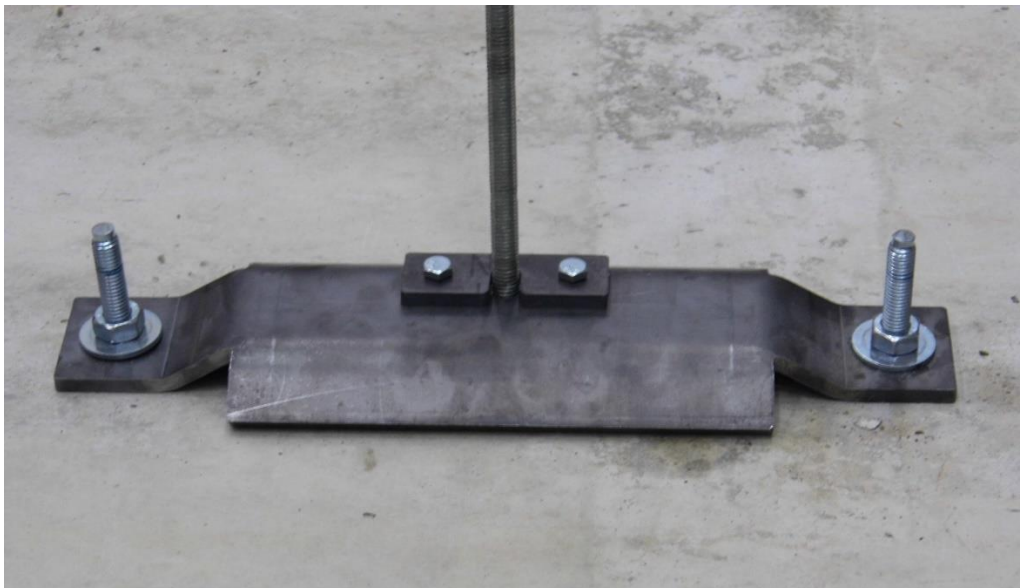
**Figure 2. View of the test specimen installed on the soffit of the hollow core slab unit**

The 10 mm diameter hanger rod was then fitted to the bracket and two Hilti M10 HKH hollow deck anchors were fitted through the bracket. The anchors were fitted through the holes in the slab unit and tightened. Note that initially the anchor began to force the outer sleeve apart under moderate tightening load and then reached a point where the load increased markedly. A view of the bracket in its installed state is given in Figure 2. The status of the sleeve once the anchor was tightened is shown in Figure 3.

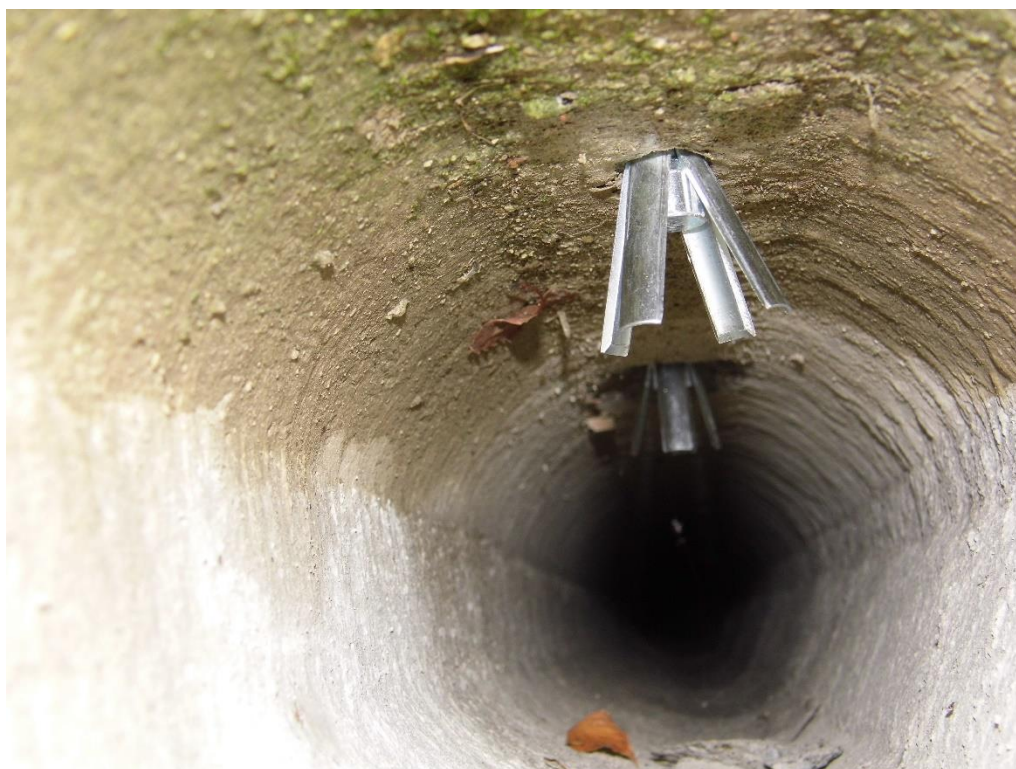
**Figure 3. View of the anchor sleeve once fully tightened**

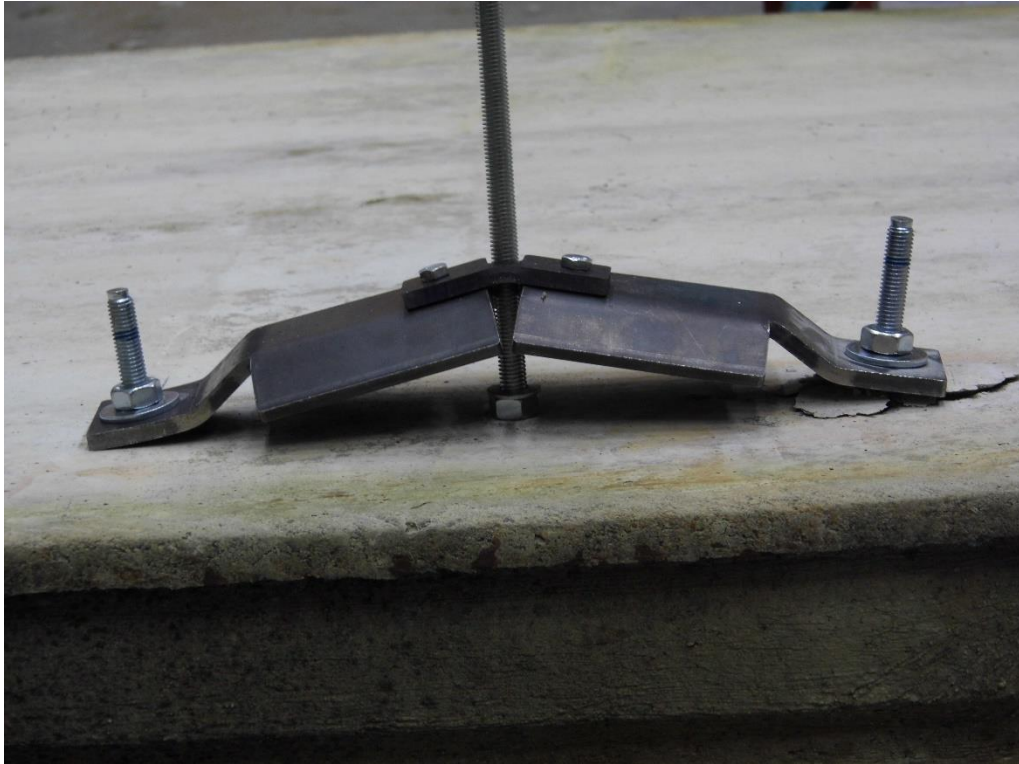
**Figure 5. Typical failure mode for all specimens except specimen 2**

In all specimens except specimen 2, the slab cracked at one of the anchors and a cone failure appeared (Figure 5) at the peak load. The failure mode for Specimen 2 was stripping of the nut from the hanger rod.
